## THE LAND TITLE BUILDING Philadelphia, Pennsylvania

# PRESERVATION Tech Notes

NUMBER 2

## Stabilization and Repair of a Historic Terra Cotta Cornice

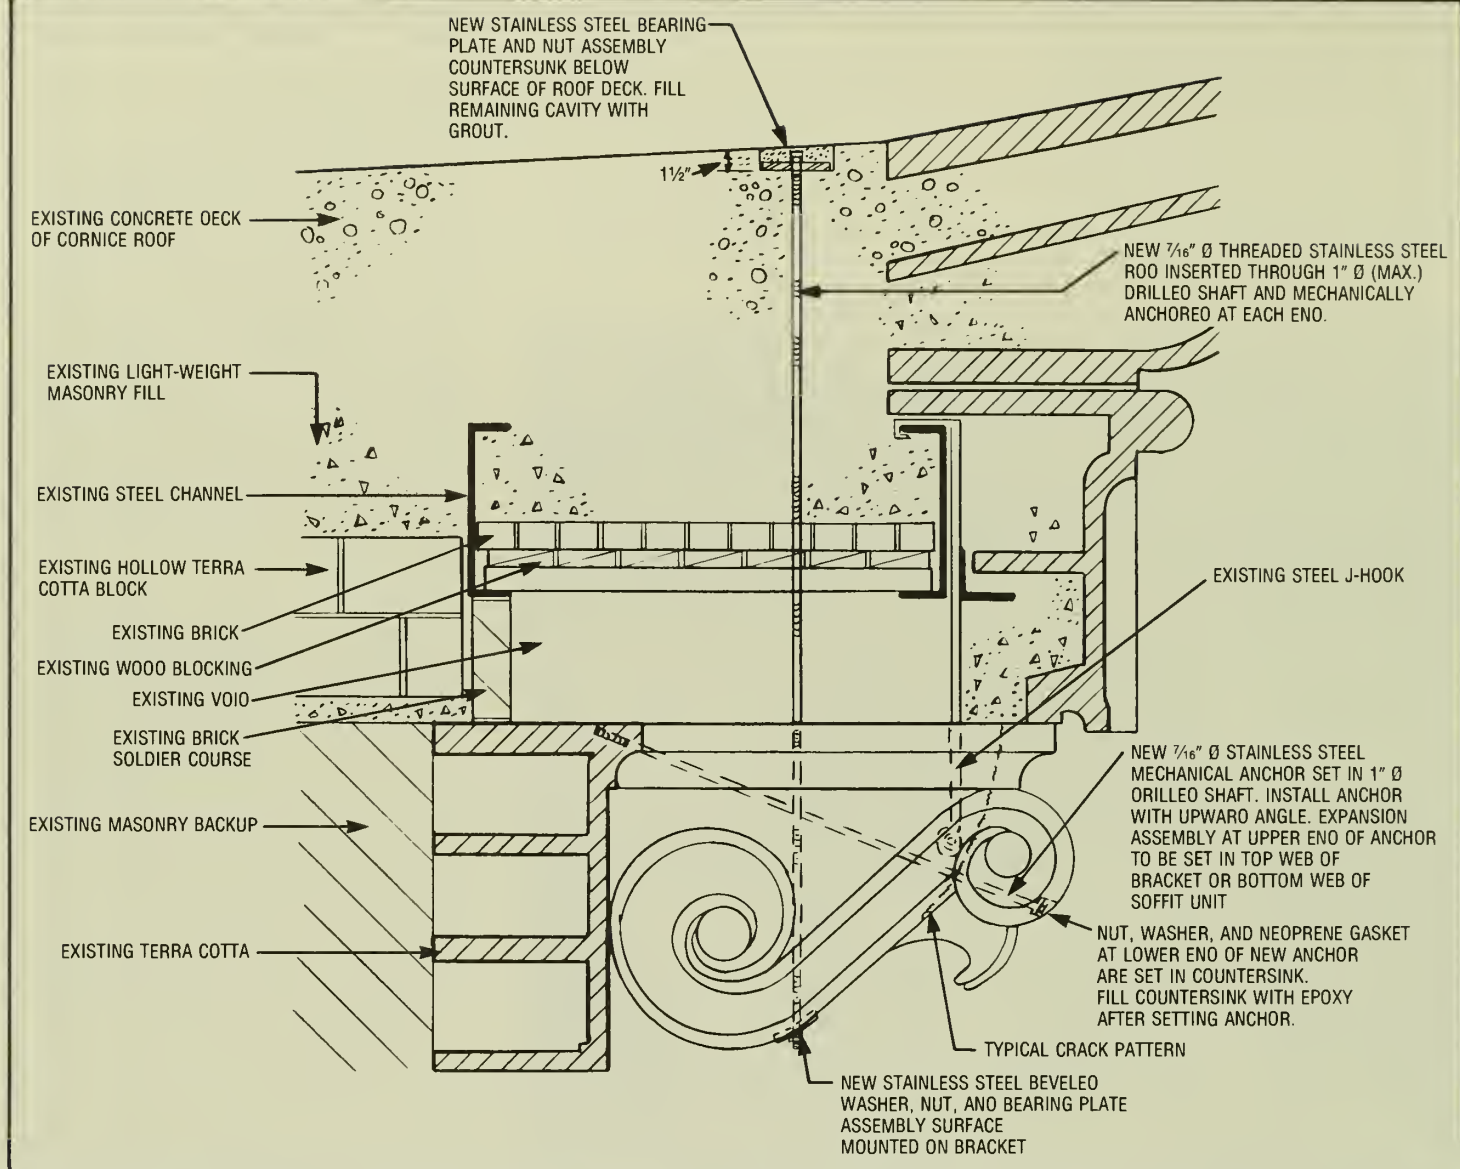
Figure 5. Detail section through the cornice showing the manner in which the vertical and angled outer scroll anchors were installed in the bracket units. The vertical hash-marks represent a typical crack pattern found in brackets which had not yet lost their outer scrolls. All 128 brackets received angled outer scroll anchors and about 80 received vertical anchors. Drawing by Jeffrey S. Levine.

the cornice. Four general categories of anchors were employed: vertical bracket anchors; angled outer scroll anchors; fascia clip-angles; and other miscellaneous mechanical anchors (see figures 5-7). Over 750 new stainless steel anchors, ranging in length from 9" to 6', were installed to secure approximately 350 loose and cracked terra cotta units to the structural steel or masonry backup of the cornice.

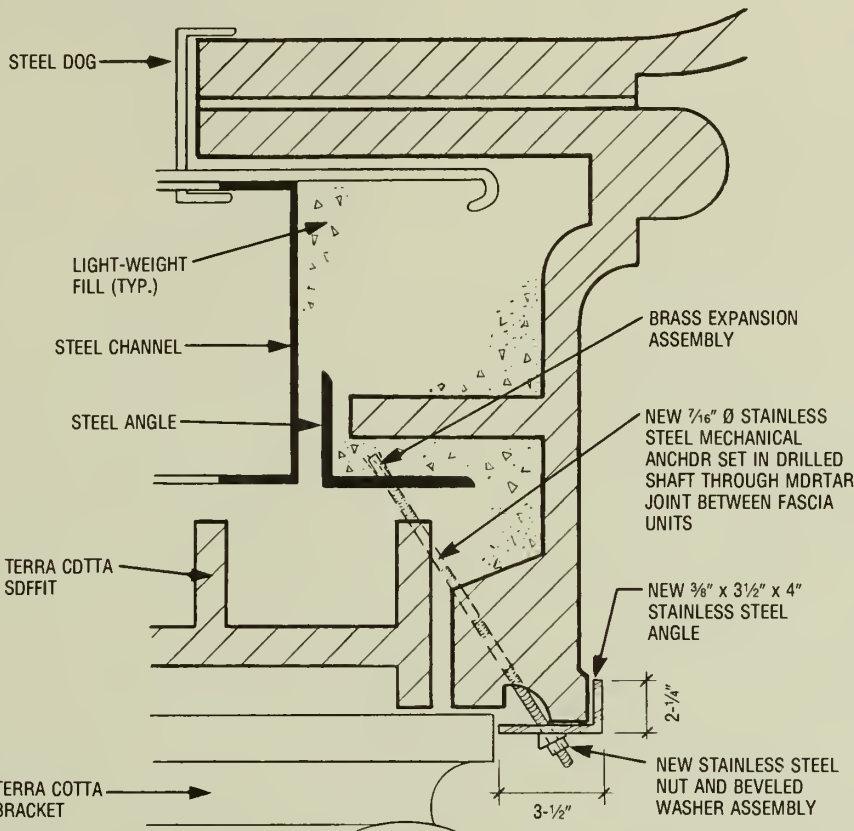
Figure 6. Detail section through the fascia of the cornice showing the installation of a fascia clip-angle anchor. Clip-angles were placed in the joints between fascia units—128 total. Drawing by Jeffrey S. Levine.

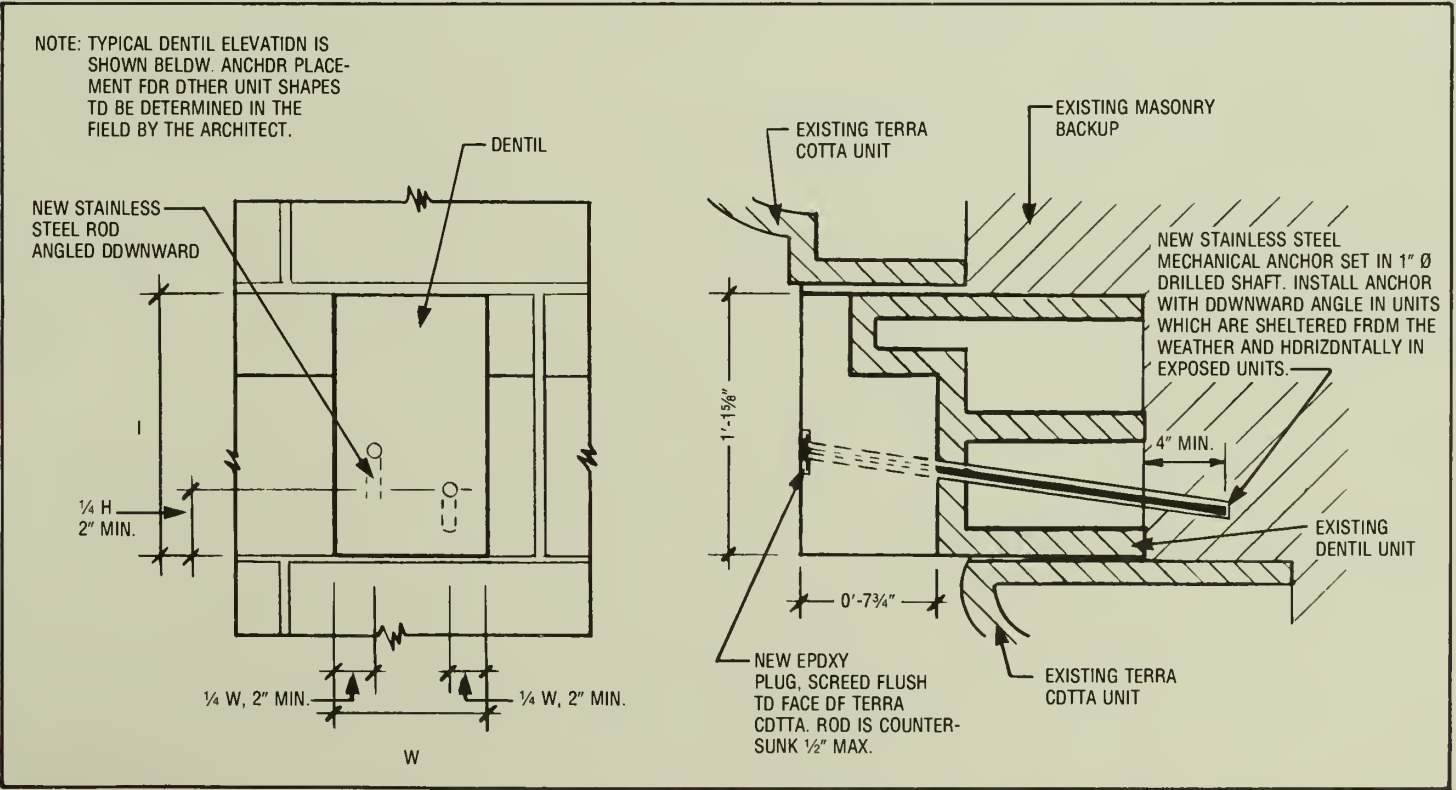
Figure 7. The typical terra cotta anchor detail is shown here for a dentil unit. Other terra cotta units with cracked internal webs were anchored in a similar fashion. Roughly 30% of all terra cotta units, exclusive of the brackets, were anchored in this manner. Drawing by Jeffrey S. Levine.

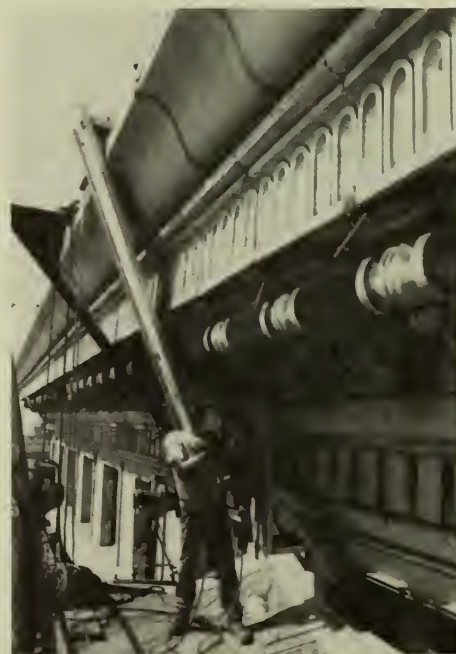
Figure 9. Drilling 6' long vertical holes through the cornice, in a variety of materials, was a delicate operation requiring great skill and specialized drilling equipment. The aluminum drilling jig provided the precise alignment needed to drill the holes for the vertical and angled bracket anchors. Drilling of a vertical anchor is shown. To create an angled outer scroll anchor hole, the drill was mounted on the angled portion of the jig, which passed directly in front of the bracket. Hand-drilled holes could be completed in 15-30 minutes, depending on the depth of the hole and the type of backup material encountered (e.g., brick, terra cotta, light-weight concrete, steel). Holes drilled with the jig required more time, 30-60 minutes, as alignment was more critical and it took time to set the jig in the proper position. Photo by Jeffrey S. Levine.

Drilling of the vertical and angled bracket anchors was accomplished using a drilling jig custom-fabricated out of  $\frac{1}{4}$ " aluminum plate. The jig slid on tracks mounted on the roof deck and on the wall of the building, just below the cornice (see figure 9). All other holes were aligned and hand drilled by skilled mechanics.

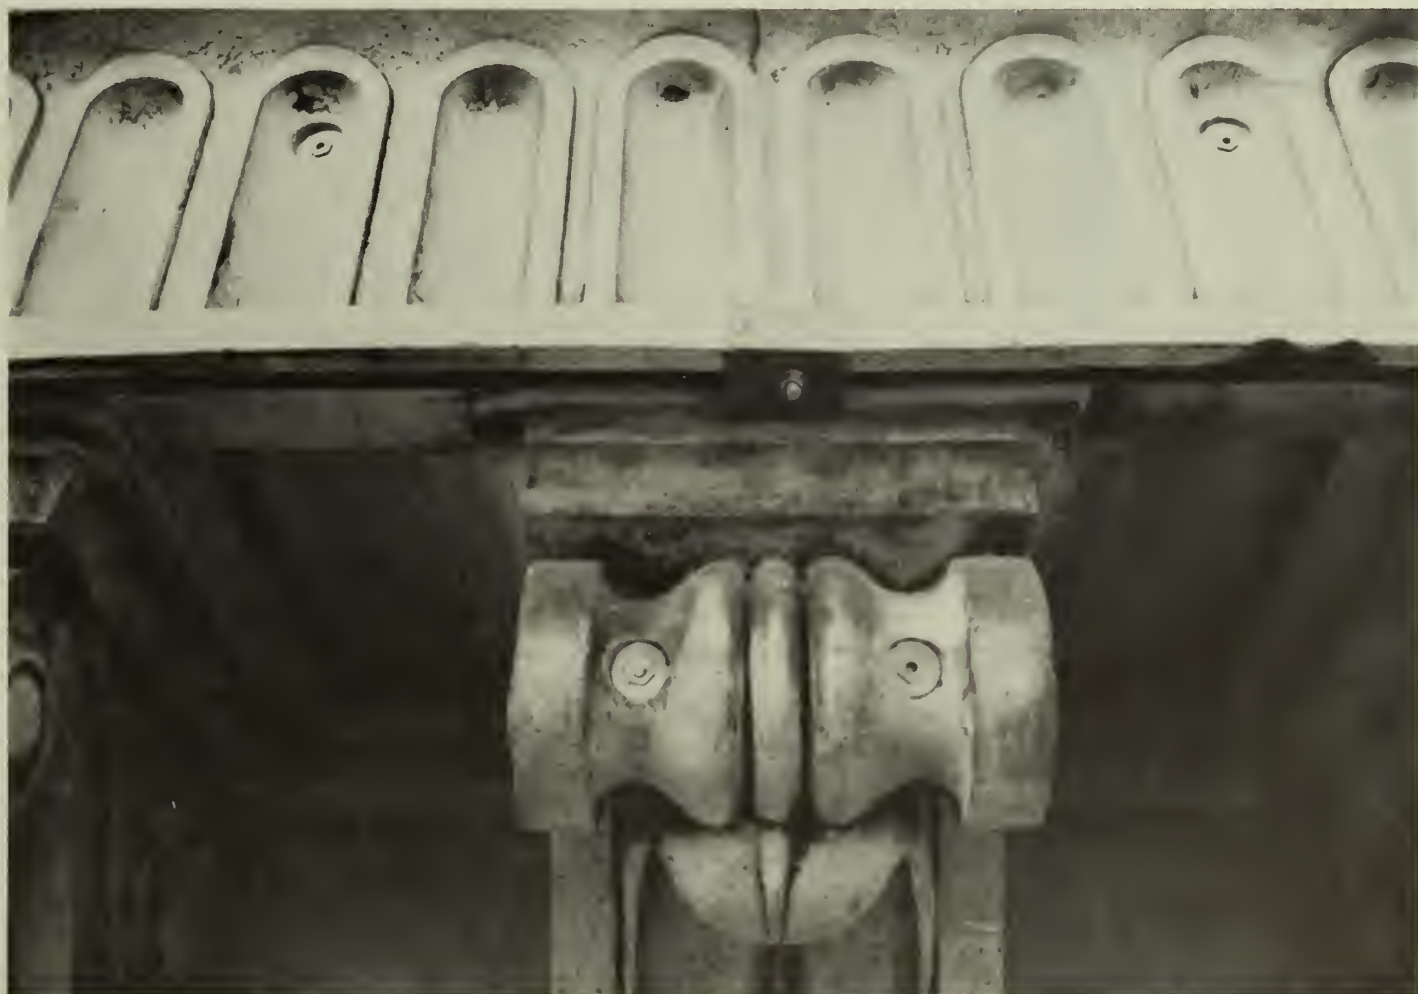
**Figure 11.** Completed anchor installations at a fascia and bracket. The countersink holes penetrate no more than half the thickness of the outer wall of the terra cotta and were filled later with epoxy.

As it turned out, the cornice construction was not very consistent and anchor placement varied according to the location of cracks. As soon as the initial order of fixed length anchors was used up, the drilling crew resorted to using all variable length anchors since these could easily be cut to the exact length required for any given situation (see figure 11).
